## CHARACTERIZATION OF MULTIAXIAL WARP KNIT COMPOSITES

H. Benson Dexter  
NASA Langley Research Center  
Hampton, Virginia

### INTRODUCTION

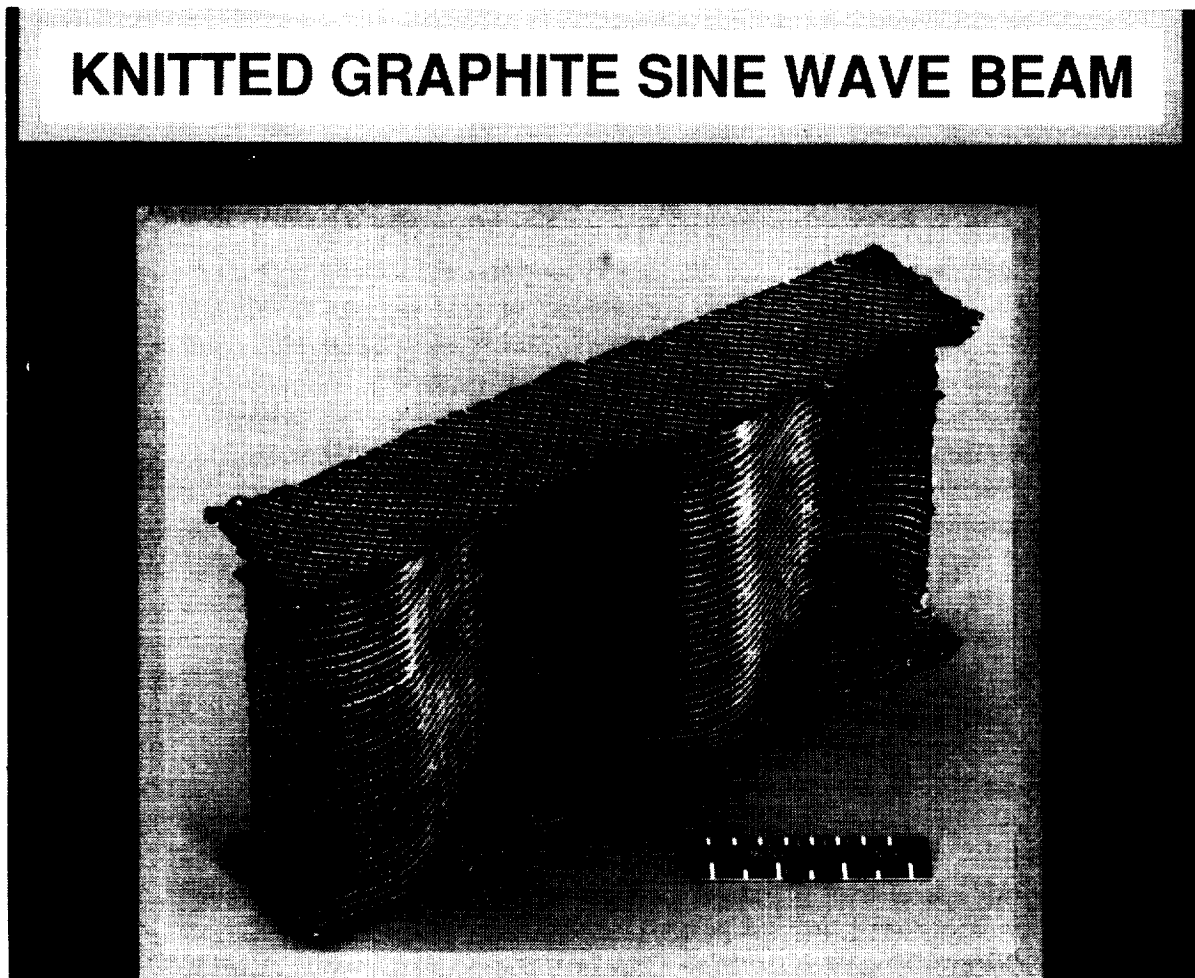
Figure 1

The potential aerospace applications of multiaxial warp knit fabrics include broadgoods replacement for biaxial woven fabric, postformed structural shapes, and dimensionally stable sheet stock for pultrusion. The broadgoods that can be produced with multiaxial knitting machines include  $[0, 90]$ ,  $[\pm\theta]$ ,  $[0 \pm \theta]$ ,  $[90 \pm \theta]$ , and  $[0, 90, \pm\theta]$  orientations. An example of a postformed structural shape is shown in figure 1. The knitted sine wave beam was formed over forming blocks and the knitted plies were tacked together with a powdered epoxy tackifier.

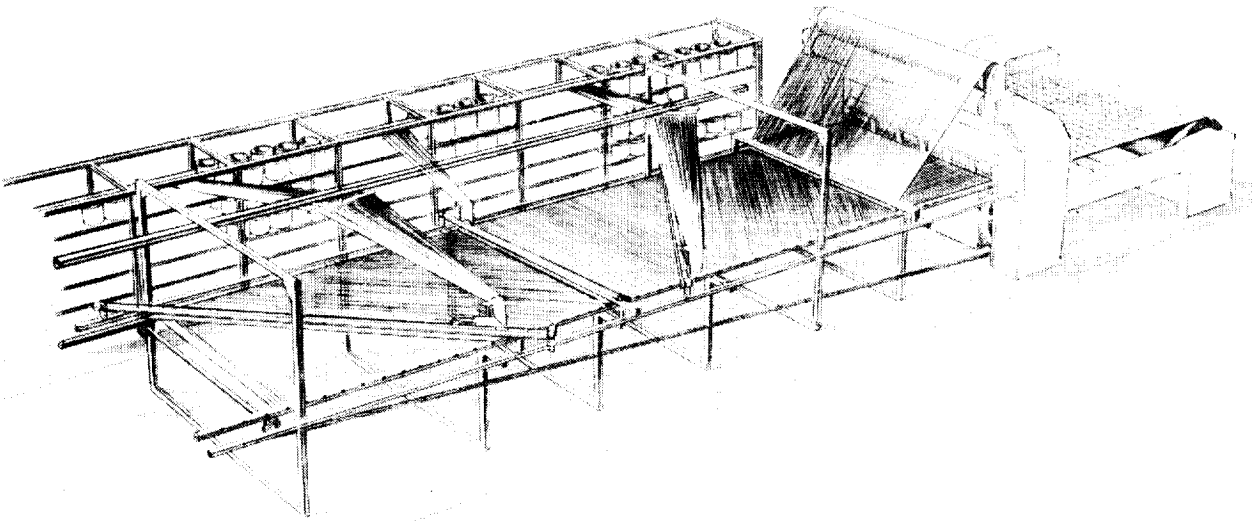
Figure 2

The multiaxial warp knit fabric obtained from Hexcel Hi-Tech was fabricated on a machine that was developed by Hexcel Hi-Tech, figure 2. The Hexcel Hi-Tech machine can produce up to an 8-ply fabric with ply orientations of  $(0, 90, \pm\theta)$ , with  $\theta$  ranging from 30 to 90 degrees. The machine can produce fabrics up to 100-inches wide at a rate of 50 lineal yards/hour. The fabric for this investigation was produced by laying down bands of 6K carbon tows. The 0- and 90-degree plies had 38 tows per band and the  $\pm 45$ -degree plies had 27 tows per band to provide a balanced areal weight. The fabric produced had an average areal weight per ply of  $430 \text{ g/m}^2$ . The sketch in figure 2 shows that the 90- and  $\pm 45$ -degree tows are laid down by yarn carriers moving along fixed guides. The 0-degree tows are laid down off a beam just prior to the 4-ply stack being knitted together. A chain stitch was used to knit the fabric plies together.

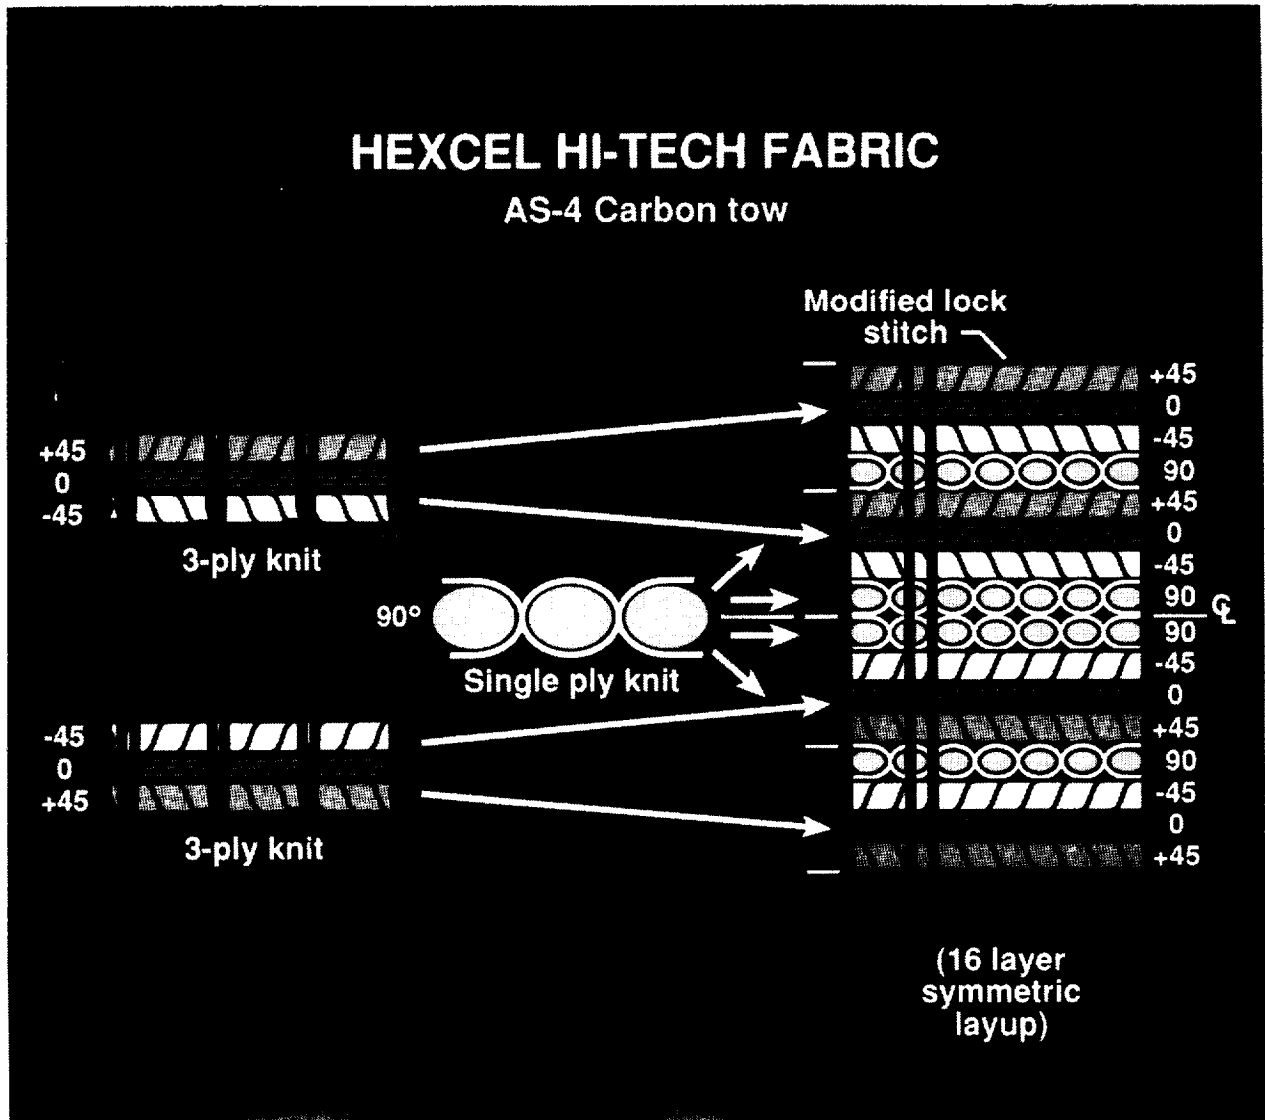
Figure 3

Hercules AS-4, 6K epoxy-sized carbon tows were used to produce the fabric. A 16-ply quasi-isotropic  $(+45, 0, -45, 90)_{2s}$  fabric preform stack was fabricated by Hexcel Hi-Tech as shown in figure 3. Three knitted ply subgroup patterns were used to build up the required thickness as indicated in the figure. The 3-ply and single-ply subgroups were produced by knitting the carbon tows together with a 70 denier polyester yarn. Eight subgroups were stacked to form the full 16-ply laminate. Some of the 16-ply stacks were stitched together with T-900-1000-50A carbon stitching yarn using a modified lockstitch.

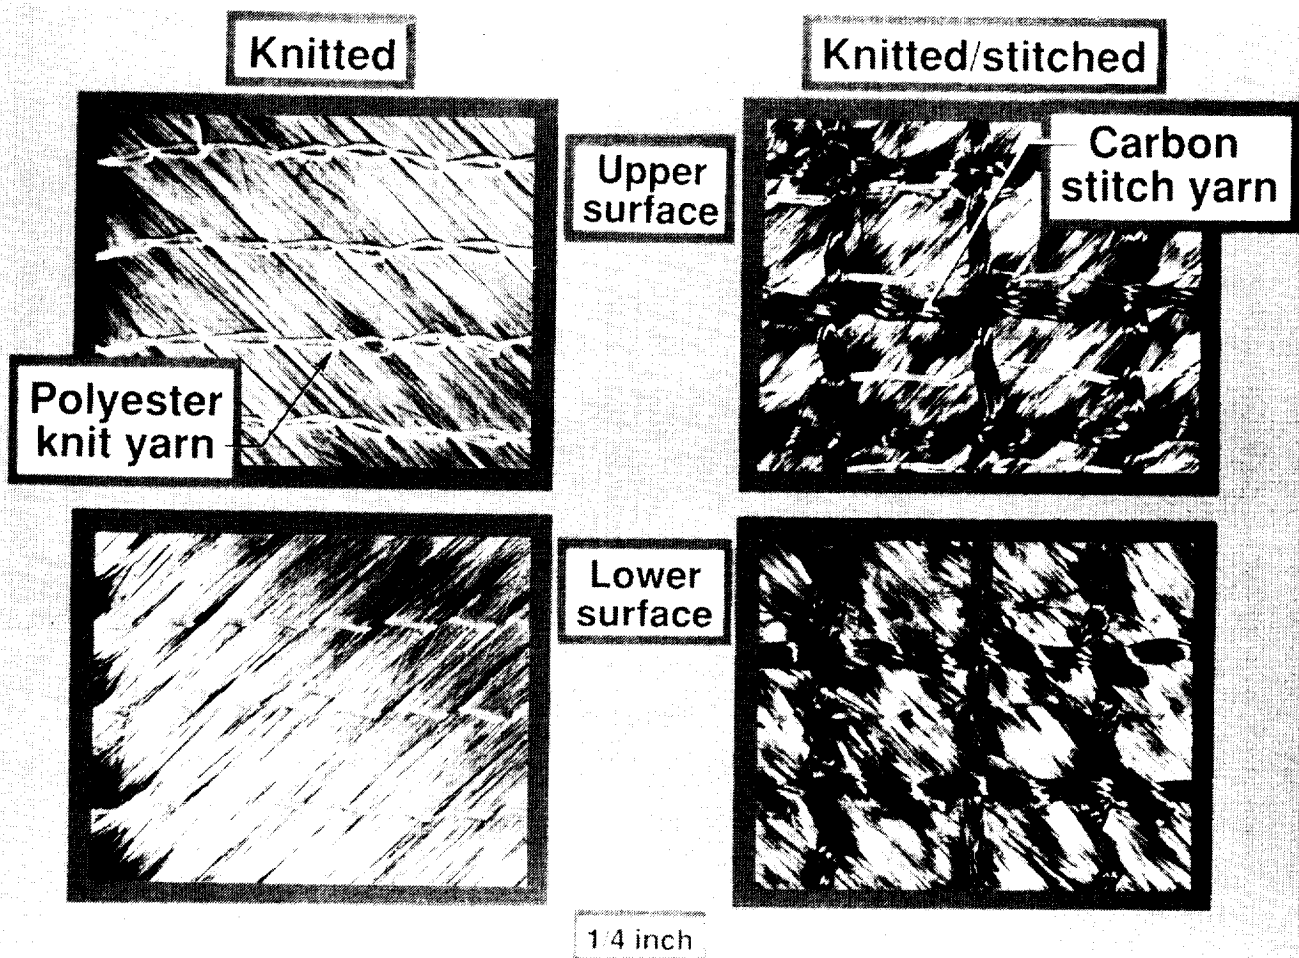
Figure 4

The Hexcel Hi-Tech knitted and knitted/stitched fabrics are shown in figure 4. A 70 denier polyester yarn was used to knit the carbon tows together. A chain stitch was used to knit the individual tows together and a modified lockstitch was used to stitch the 16-ply stack together. The polyester knitting yarns were spaced in rows 1/6-inch apart with a pitch of 9 stitches/inch. The carbon stitching yarns were spaced in rows and columns 1/4-inch apart with a pitch of approximately 8 stitches/inch. The polyester knit yarns pierced the carbon tows and imparted limited damage to some of the tows. The photographs shown in figure 4 indicate only minimal inplane distortion of the carbon tows due to penetration of the polyester knitting yarns. The Toray T-900-1000-50A carbon stitching yarn was much larger in diameter than the polyester knitting yarn, which resulted in additional fiber distortion and damage.

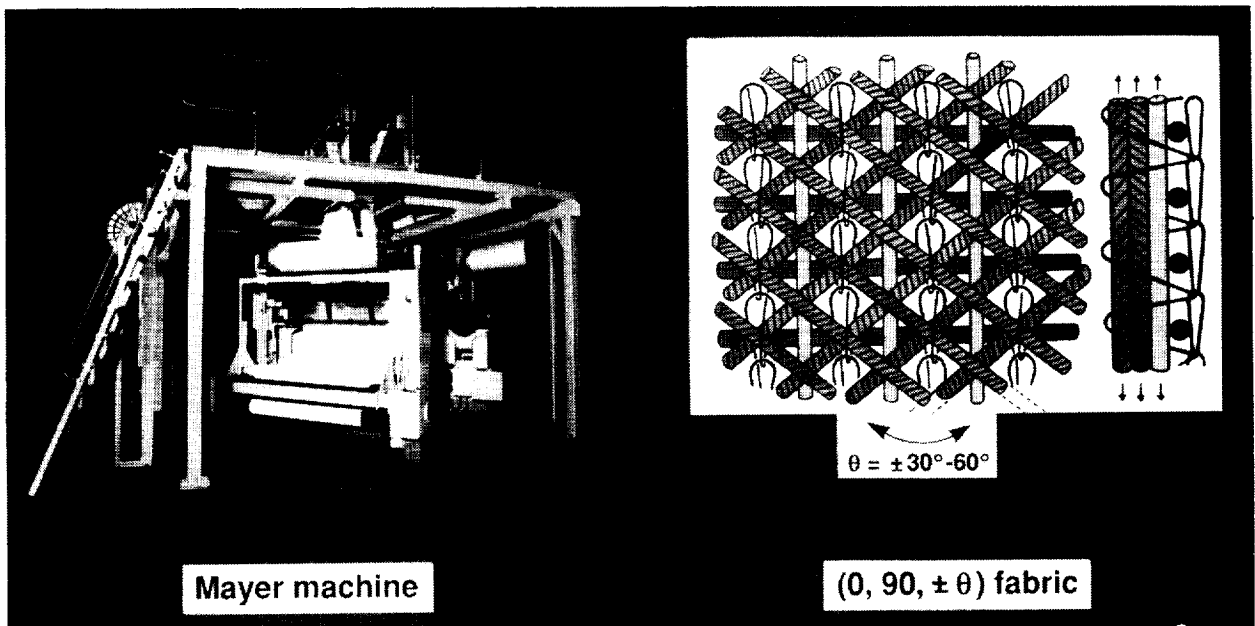
Figure 5

The multiaxial warp knit fabric obtained from Milliken was fabricated on a machine that was manufactured by the Mayer Textile Machine Corporation, figure 5. The Milliken machine can produce a 4-ply fabric with ply orientations of  $(0, 90, \pm\theta)$ , with  $\theta$  ranging from 30 to 60 degrees. Fabrics with  $(0, 90)$ ,  $(0\pm\theta)$ ,  $(90\pm\theta)$ ,  $(\pm\theta)$  and  $(0, 90, \pm\theta)$  fiber orientations can also be produced with the Milliken machine. In addition, an auxiliary backing material can be included in the knitted fabric. The machine can produce fabrics up to 62 inches wide at a rate of 50 lineal yards/hour. The machine was operated at approximately 30 lineal yards/hour to minimize damage to the carbon tows. The tow count for the fabric produced for this investigation was 12 tows/inch in the warp and fill directions and 17 tows/inch in the  $\pm 45$ -degree directions of the fabric. A chain stitch was used to knit the  $(-45, +45, 0, 90)$  plies together. The fabric produced had an average areal weight per ply of  $430 \text{ g/m}^2$ .

The Milliken fabric was made on the knitting machine discussed in figure 5. The fabric design shown in figure 6 was produced with Hercules AS-4 epoxy-sized carbon tows. The 0- and 90-degree plies were produced with 12K tows, whereas 9K tows were used for the  $\pm 45$ -degree plies. This tow distribution was required to achieve similar ply areal weights because of the different tow count for the off-axis plies. Only the 4-ply subgroup ( $-45$ ,  $+45$ , 0, 90) shown in figure 6 was produced for this investigation. An additional 4-ply subgroup ( $+45$ ,  $-45$ , 0, 90) would be required to produce a symmetric quasi-isotropic fabric preform. Four 4-ply subgroups were stacked to form the full 16-ply laminate. Note that the 16-ply stack shown in figure 6 is unsymmetric. The 4-ply subgroup was produced by knitting the carbon tows together with a polyester yarn. Some of the 16-ply stacks were stitched together with Kevlar 29 1500 denier stitching yarn using a chain stitch.

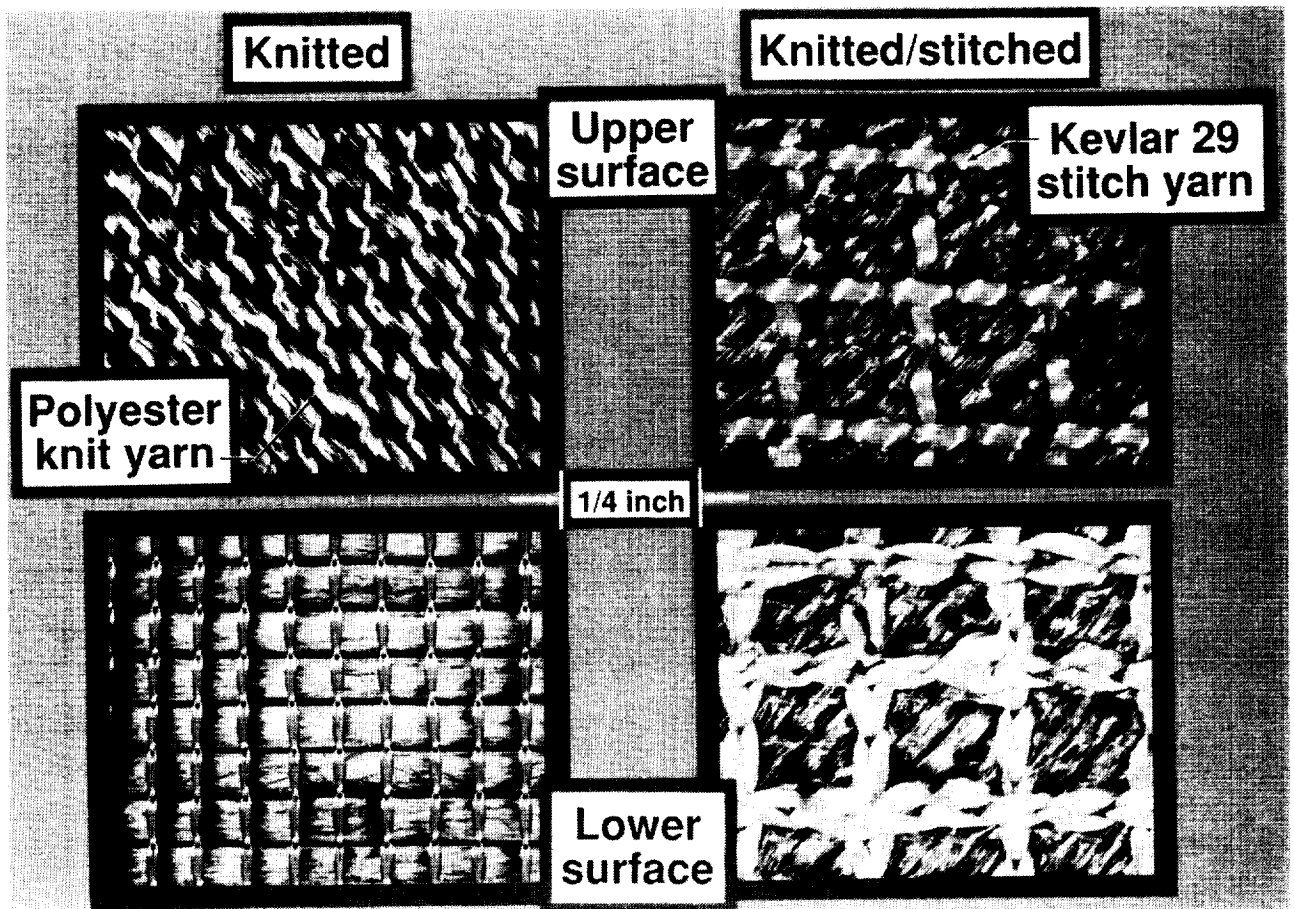
Figure 7

The Milliken knitted and stitched fabrics are shown in figure 7. A 150 denier polyester yarn was used to knit the carbon tows together. A chain stitch was used to knit the individual tows together and a Kevlar chain stitch was also used to stitch the 16-ply stacks together. The polyester knitting yarns were spaced in rows 1/12-inch apart with a pitch of 12 stitches/in. The Kevlar 29 stitching yarns were spaced in rows and columns 1/4-inch apart with a pitch of approximately 8 stitches/inch. The polyester knit yarns surrounded the individual carbon tows which resulted in a gap of approximately 0.01-inch between the carbon tows. Since the knitting needles did not pierce the carbon tows, minimal damage was imparted to the fabric as a result of the knitting operation. The photographs in figure 7 indicate a high degree of uniformity and yarn straightness in the knitted fabric. The Kevlar 29 1500 denier stitching yarns caused some distortion in the carbon tows, especially at the intersection of the rows and columns.

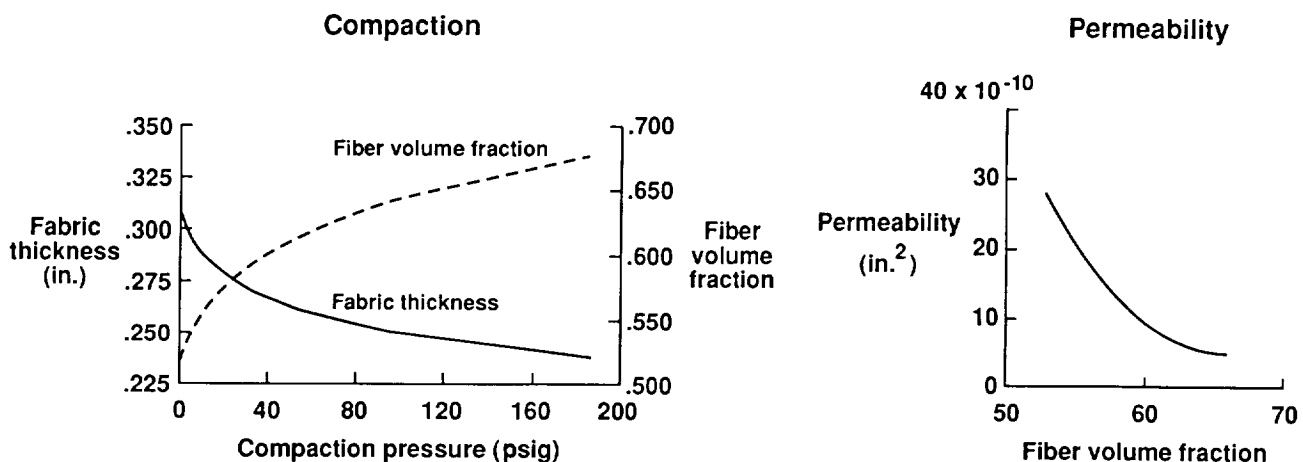
Figure 8

The compaction and permeability characteristics of a fabric can be used as an aid in the development of infiltration and cure cycles. As part of a NASA Langley grant, Virginia Polytechnic Institute and State University (VPI & SU) developed experimental techniques to measure fabric compaction and permeability. As shown in figure 8, the fiber volume fraction and fabric thickness is a nonlinear function of compaction pressure. The Hexcel Hi-Tech knitted/stitched fabric had a nominal uncompact fiber volume fraction of approximately 51 percent and a thickness of approximately 0.310-inch. To achieve a fiber volume fraction of over 62 percent and a final thickness of 0.250-inch, a compaction pressure of approximately 90 psig is required.

Also shown in figure 8 is the effect of fiber volume fraction on permeability. Permeability is a function of fabric architecture, compaction, porosity, and flow direction. Permeability along a fiber bundle can be an order of magnitude greater than transverse to the fiber bundle. Through-the-thickness stitching may increase fabric permeability by providing additional flow paths through the thickness of the fabric. Tightly woven or high fiber volume fraction fabrics would have less porosity and thus be more difficult to infiltrate with resin. The compaction and permeability data generated under the VPI & SU grant were used to generate infiltration and cure cycles for the Hexcel Hi-Tech knitted/stitched fabric and the Milliken knitted fabric.

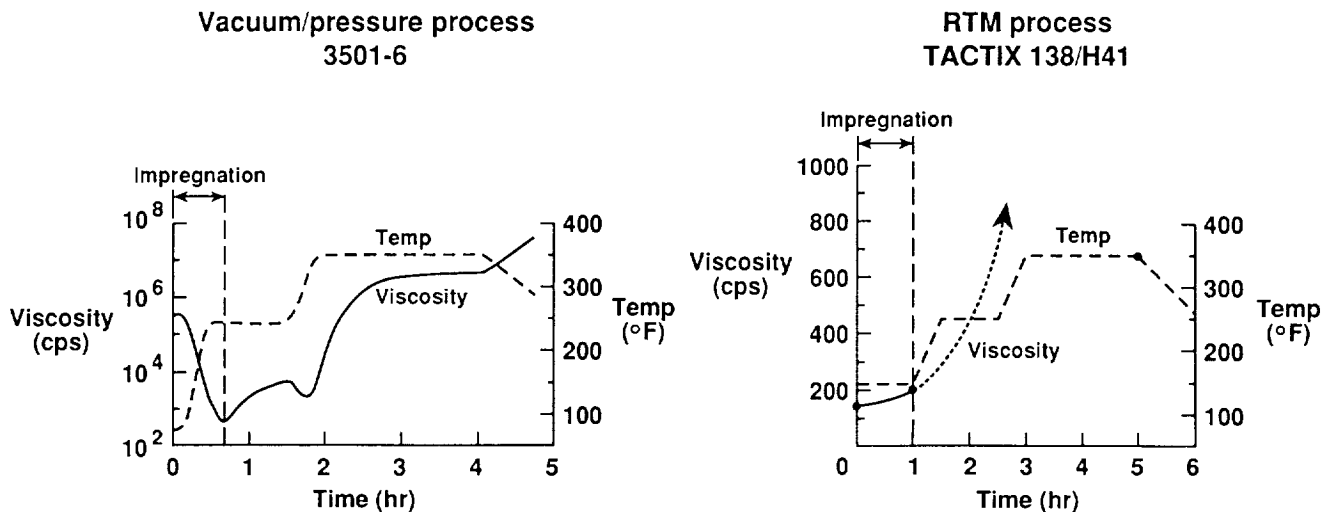
Figure 9

Three types of resins and associated impregnation processes were used in this investigation. Viscosity profiles and cure cycles used for two of the resins, Hercules 3501-6 and Dow Tactix 138/H41, are shown in figure 9. The 3501-6 resin is a solid at room temperature and was used in a vacuum/pressure process where a resin film was melted and infiltrated through-the-thickness of the fabric. The 3501-6 resin melts during a ramp up to 245°F at which time a minimum viscosity of approximately 500 cps is achieved. The fabric is fully impregnated during the low viscosity window. Full vacuum plus 2 psi of platen pressure is used to impregnate the fabric. Total impregnation is completed within 40 minutes and the platen pressure is increased to 90 psi to insure proper compaction. After a 1-hour hold at 245°F, the temperature is ramped to 350°F and the cure cycle is completed after a 2-hour hold.

The Tactix 138/H41 epoxy resin mixture has a room temperature viscosity of over 1000 cps. To reduce the viscosity, the resin is heated to 150°F for impregnation. The viscosity drops below 200 cps for approximately 1 hour at which time full impregnation occurs. Resin is injected into the mold cavity and fabric under 25 psi pressure and full vacuum to remove entrapped air. The resin exit valve in the RTM tool is closed and the cure cycle is initiated. Temperature is raised to 250°F and held for 1 hour while the resin gels. A mold clamping pressure of 200 psi is applied to close the mold and to achieve the desired laminate thickness. The final cure is completed after a 2-hour hold at 350°F.

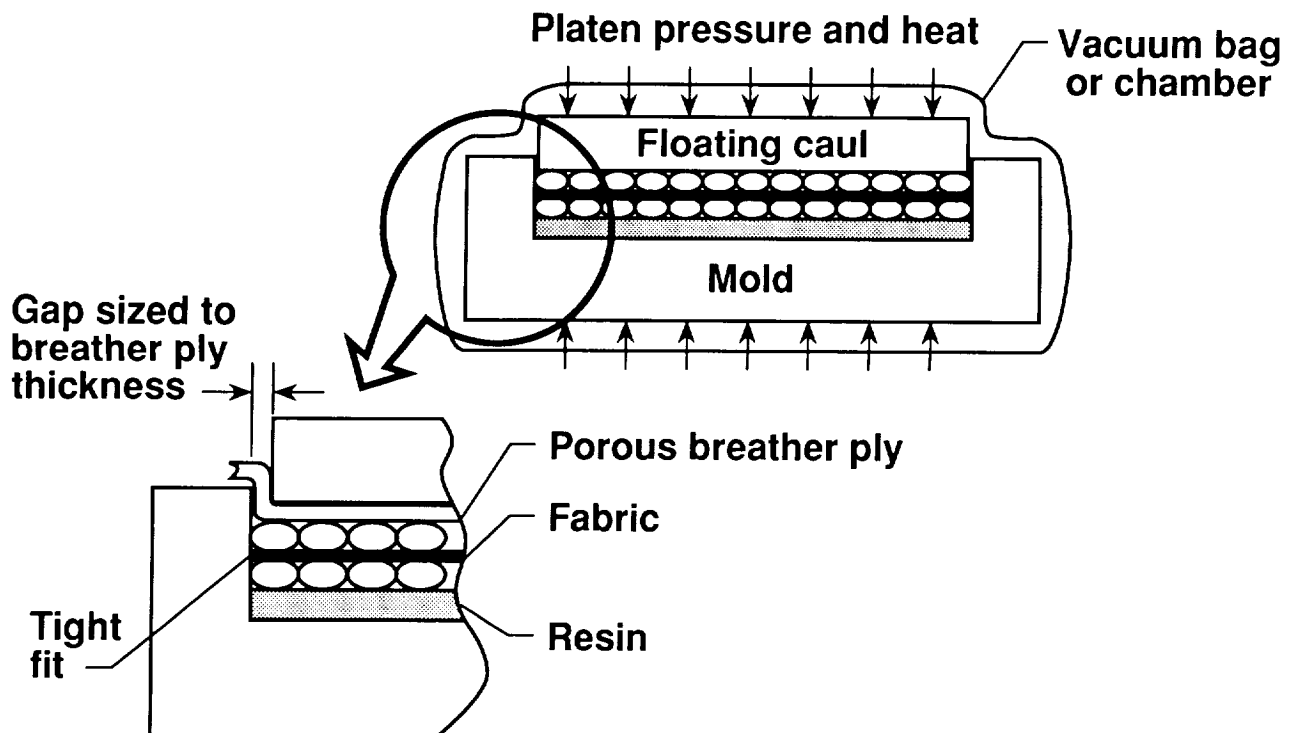
Figure 10

The vacuum/pressure impregnation process was used to mold panels with Hercules 3501-6 resin. As shown in figure 10, a resin film is placed in the bottom of the mold and resin flow is in one direction, up through the thickness of the fabric. A vacuum press is used to apply heat and pressure and to evacuate entrapped air. The resin is weighed to give the desired volume fraction, melted, degassed under vacuum, and poured into the mold cavity where it solidifies. The fabric is carefully trimmed to fit the 12-inch by 12-inch cavity size and placed in the mold so that all edges have a slight press fit. This insures that there are no gaps to allow resin to escape around the fabric. A breather layer of porous Teflon-coated fiberglass is placed over the fabric to allow air to escape, but to prevent excessive resin bleed. The caul plate is placed in the mold cavity to apply pressure to the fabric. Pressure must be close to that required to achieve the desired thickness and fiber volume; too much pressure results in a thin panel and too little pressure leads to voids. The caul plate is sized to allow only enough gap for the breather fabric to extend out of the mold. This tight fit allows excess resin to bleed out and provides a path for air venting. The entire mold assembly is placed between heated platens in a vacuum press for the prescribed cure cycle. Since the fabric is not pressed to thickness stops, slight variations in final part thickness may result.

### Variable cavity depth mold; through-thickness flow

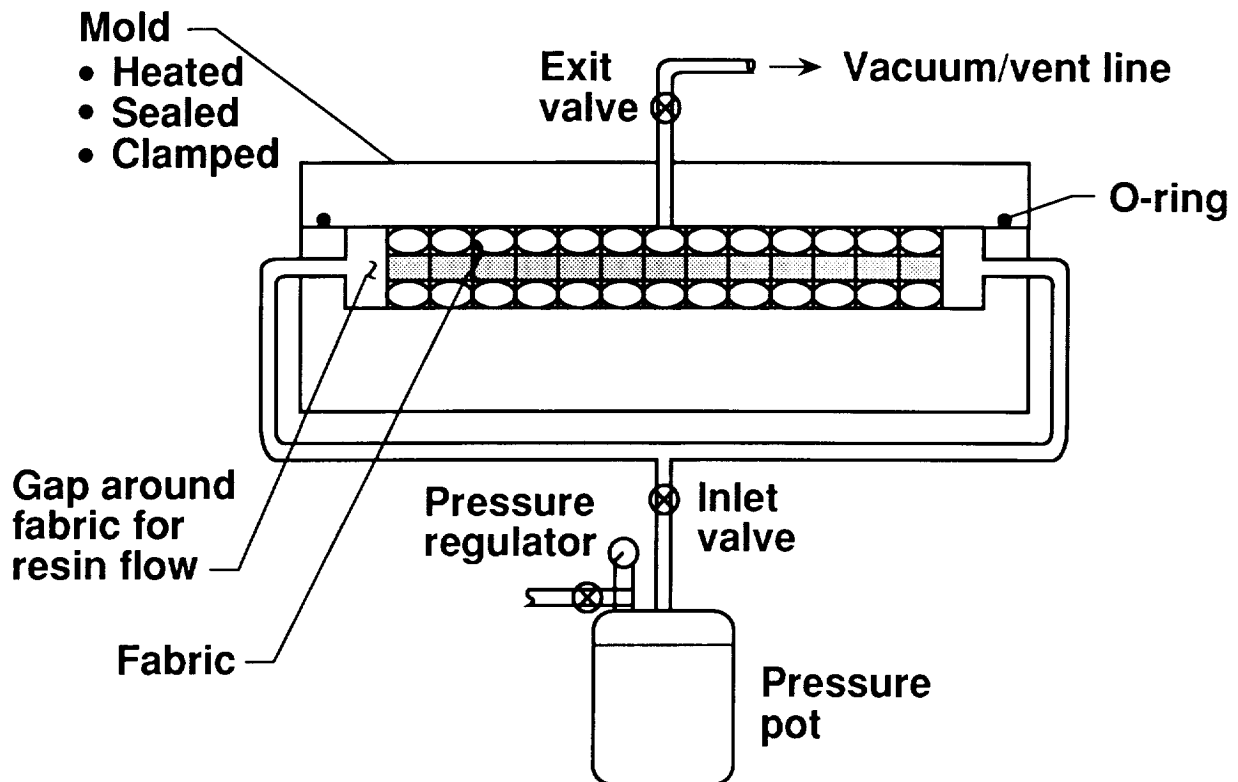
Figure 11

The resin transfer molding (RTM) process shown in figure 11 was developed by Boeing Aerospace under contract to NASA Langley. Panels 11.5-inch by 11.5-inch by 0.250-inch were molded and shipped to NASA Langley for testing. The RTM method is used to mold panels with resins having stable, low viscosities at room or slightly elevated temperature, such as Dow Tactix 138/H41. Resin flow is two-dimensional in the plane of the fabric. As indicated in the figure, an O-ring is used to seal the mold to prevent resin leakage and air entrainment. The mold assembly is placed between two platens in a hydraulic press to close the mold and apply sufficient pressure to debulk the fabric and seat the O-ring. The mold cavity depth is sized to achieve a prescribed fabric thickness and fiber volume fraction.

Resin enters the mold from a pressurized tank and fills a channel around the perimeter of the fabric. Resin flows radially inward through the fabric to an exit port in the center of the mold. A vacuum pump is attached to the exit port to remove excess air. Once the fabric preform is fully infiltrated and air is evacuated, the exit valve is closed and the prescribed cure cycle is followed. Cured panels may have minor thickness variations due to machining tolerances of the mold.

### Fixed cavity depth mold; in-plane flow

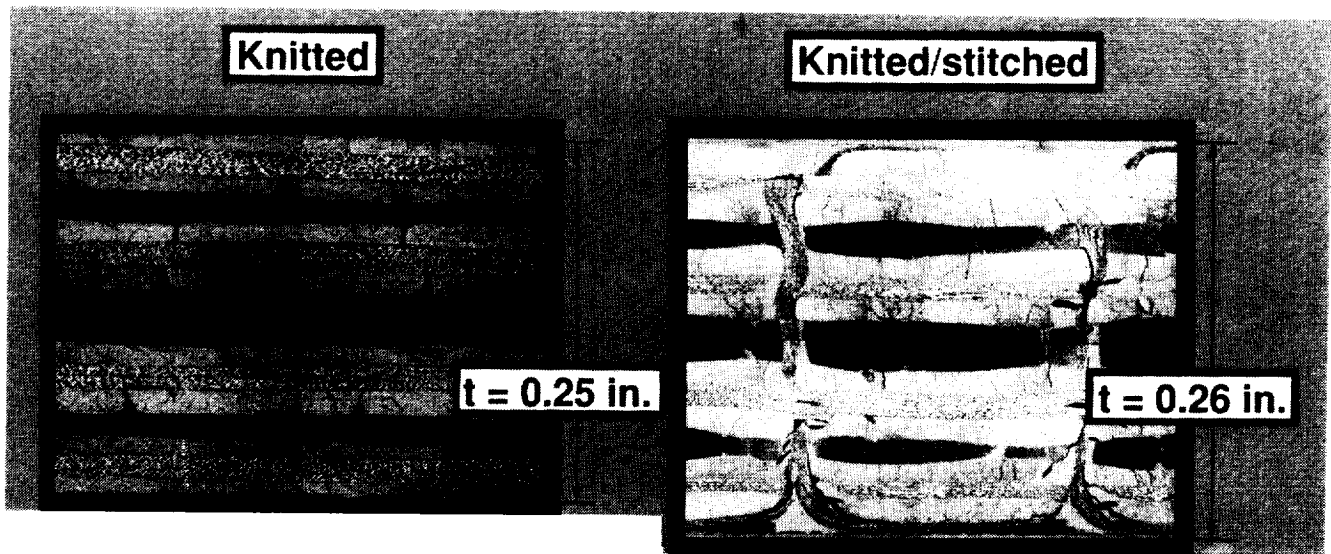
Figure 12

Photomicrographs of Hexcel Hi-Tech laminates are shown in figure 12. Good compaction of the plies was achieved as evidenced by the nesting of the 90-degree plies. The well-defined shape of the 90-degree plies at the mid-plane of the knitted laminate is a result of constraint provided by the polyester knitting yarn. As a result, resin-rich areas are evident between the tow bundles. There are two significant characteristics evident in the knitted-stitched laminate shown in figure 12. Large resin-rich areas are evident around the carbon fiber stitching yarns and microcracking is evident throughout the laminate. The microcracking is caused by residual thermal stresses that occur during cool-down of the laminate after the resin is cured. As indicated in figure 12, void-free laminates were produced.

During the course of this investigation several laminates were fabricated by the vacuum/pressure impregnation method with various levels of compaction pressure. The higher pressures resulted in laminates with higher fiber volume fractions. Fiber volume fractions, determined by acid digestion, ranged from 56 to 63 percent with an average of 59 percent.

Due to limited material availability, only one Kevlar-stitched laminate was fabricated by the vacuum/pressure impregnation process for this investigation. Significant resin-starved areas on the surface and internal porosity were evident for this laminate. Additional fabrication trials are required to optimize the resin impregnation and cure process. The photomicrograph of the Kevlar-stitched laminate shown in figure 13 indicates less microcracking than the Hexcel Hi-Tech carbon-stitched laminate shown in figure 12.

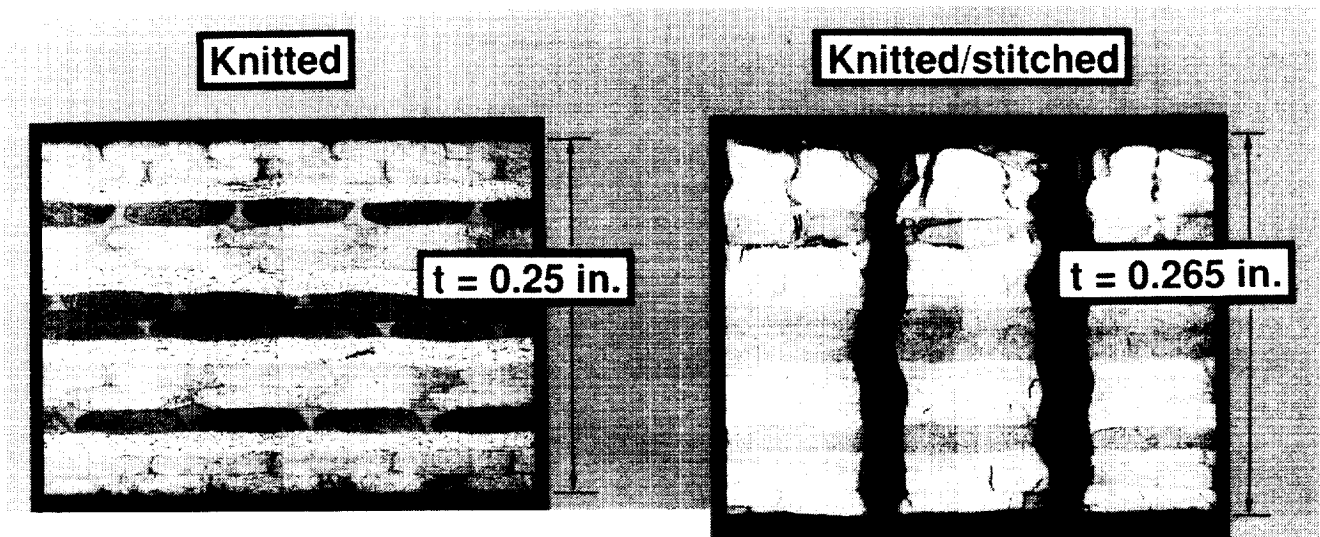
Figure 13

Photomicrographs of Milliken laminates are shown in figure 13. The 150 denier polyester knit yarns used in fabricating the  $(-45, +45, 0, 90)$  4-ply fabric provided excellent stability to the fabric. A high degree of uniformity in carbon tow spacing was achieved. The individual carbon tows could not spread to fill the inherent gaps between the tows. As a result, uniform resin-rich pockets are evident throughout the laminates. The volume fraction of the resin pockets was reduced during the course of this investigation by using less resin and applying higher pressure during the compaction portion of the cure cycle. The first laminate fabricated with a pressure of 45 psi had a thickness of 0.270-inch, whereas the laminates produced with 90 psi pressure had thicknesses ranging from 0.240-inch to 0.250-inch.

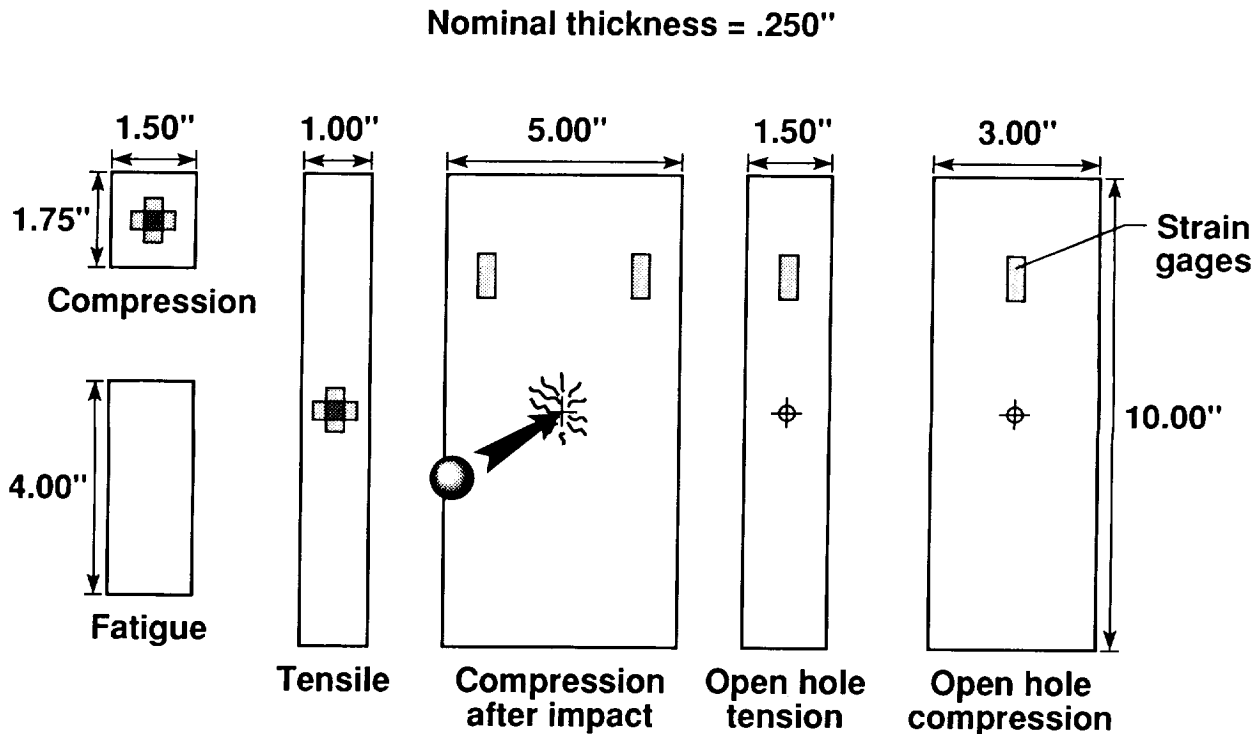
Figure 14

The test specimens used in this investigation are shown in figure 14. All the test specimens had a nominal thickness of 0.250-inch and a nominal fiber volume fraction of 60 percent. The short block compression specimens were 1.50 inches wide by 1.75 inches long, and the compression-compression fatigue specimens were 1.5 inches wide by 4.0 inches long. The tension specimens were 1.0 inch wide by 10.0 inches long. The tension and compression specimens had 1/8-inch long (0/90) stacked strain gages bonded back-to-back at mid-length of the specimens. The compression-after-impact specimens were 5.0 inches wide by 10.0 inches long and had 1/4-inch long strain gages bonded back-to-back as shown in the figure. The compression after impact specimens were impacted at approximately 30 ft-lb of energy with 0.500-inch diameter aluminum balls that were fired from an air gun. The target impact energy was 1500 in-lb per inch of laminate thickness. However, due to velocity limitations of the air gun, some of the thicker laminates were subjected to energies slightly lower than the desired level of 1500 in-lb per inch of laminate thickness.

Open hole tension and compression specimens were both 10.0 inches long and had 1/4-inch holes drilled through their centers. Tension specimens were 1.5 inches wide and compression specimens were 3.0 inches wide. Open hole specimens had 1/4-inch long strain gages bonded back-to-back as shown in the figure.

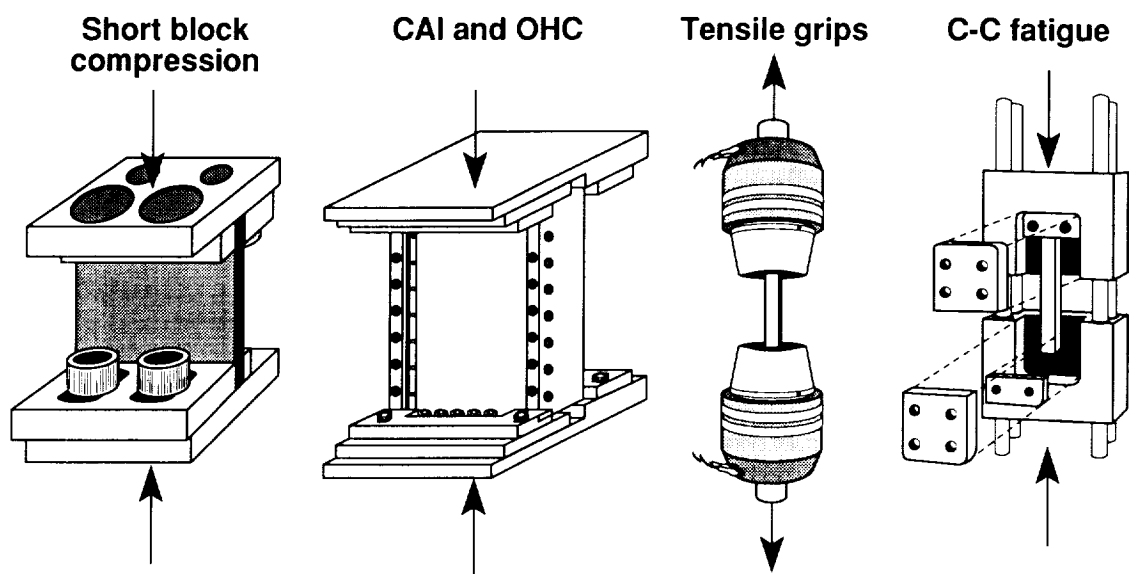
Figure 15

Sketches of the test fixtures used in this investigation are shown in figure 15. Tension and compression tests were performed to measure elastic properties and strength. Compression after impact tests were performed to determine the effect of low-velocity impact on the compression strength of the knitted fabrics. Open hole tension and open hole compression tests were performed to determine the effect of stress concentrations on residual strength. Constant amplitude compression-compression fatigue ( $R = 10$ ) tests were conducted to assess the effect of cyclic loading on residual compression strength.

The compression specimens were tested in a short block compression fixture. This fixture was used to apply uniform end-loading and to apply lateral clamping forces to the specimen ends to prevent end-brooming type failures. The specimens were tested in a 120-Kip hydraulic test machine at a load rate of 10 Kips/min until failure. Selected compression specimens were moisture conditioned and tested at 180°F. Moisture absorption was achieved by immersion of the specimens in water for 45 days at 160°F. The compression after impact and open hole compression specimens were tested in a fixture that clamps the ends and provides knife-edge supports on the sides to prevent overall panel instability. The compression after impact specimens were loaded at 20 Kips/min and the open hole compression specimens were loaded at 15 Kips/min. The tension and open hole tension specimens were tested in a 50-Kip servo-hydraulic test machine. End tabs were not used but lexan and a grit-coated wire screen were used to prevent slippage and specimen damage due to hydraulic actuated grip pressure. The tension specimens were loaded at a displacement rate of 0.05 in/min until failure.

The fatigue tests were conducted in a closed-loop servo-hydraulic test machine at a frequency of 10 Hz. The maximum number of cycles applied to the specimens was approximately 3 million cycles. The fatigue test fixture has four alignment rods that slide on linear bearings. The gripping surfaces were serrated to prevent slippage and to transmit load. In addition, end stops were used to apply end loads and to prevent slippage of the specimens.

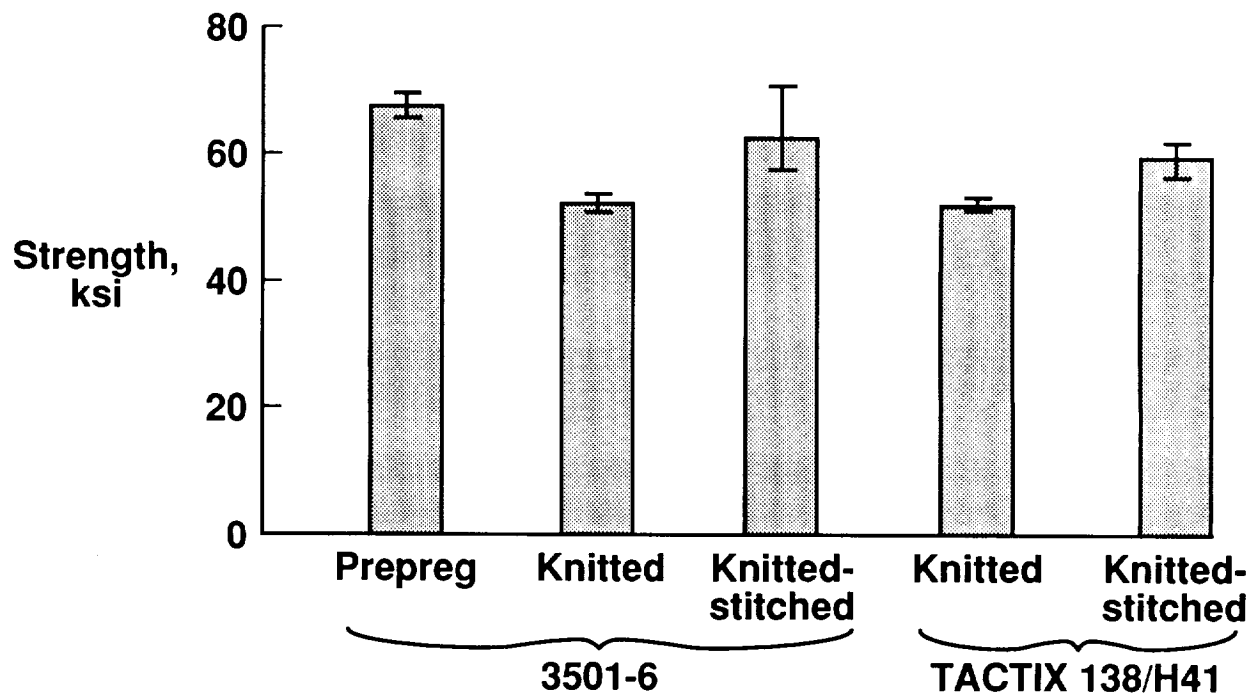
Figure 16

Average tensile strengths for the Hexcel Hi-Tech knitted and knitted-stitched fabrics are shown in figure 16. Test results are shown for laminates fabricated with Hercules 3501-6 resin and Dow Tactix 138/H41 resin. The fabric results are compared with those for AS4/3501-6 prepreg tape. The prepreg laminates were fabricated with a  $(+45_3, 0_3, -45_3, 90_3)_2$  48-ply layup which approximates the ply thicknesses for the 16-ply fabric layup. The test results indicate that the knitted-stitched laminates are stronger than the knitted laminates. These results are in contrast to results for Xerkon knitted-stitched laminates reported in reference 1, where it was found that stitching degrades the laminate tensile strength. The strength of the knitted laminates is approximately 22 percent lower than the strength of prepreg tape. The strength of the knitted-stitched laminates is only about 10 percent lower than the strength of the prepreg tape. Most of the tensile failures were in the test section; however, a few specimens failed at the edge of the grips. All specimens were tested without tabs in hydraulic pressure grips. It is possible that fiberglass tabs would improve load transfer and increase strength for all the laminates.

Average tensile strengths for the Milliken knitted fabrics that were fabricated with 3501-6 resin and BP E905L resin are shown in figure 17. The strength of the 3501-6 knitted Milliken fabric is similar to the strength of the Hexcel Hi-Tech knitted fabric discussed in figure 16. The laminates with the E905L resin were about 17 percent stronger than the 3501-6 laminates. The Milliken prepreg laminate consisted of 48 plies of AS4/3501-6 prepreg tape which were stacked unsymmetrically to simulate the 16-ply Milliken knitted laminate discussed in figure 6. The average strength of the Milliken knitted laminates is approximately 26 percent lower than the strength of the prepreg tape. Due to a limited supply of Milliken fabric, knitted-stitched tensile specimens were not fabricated.

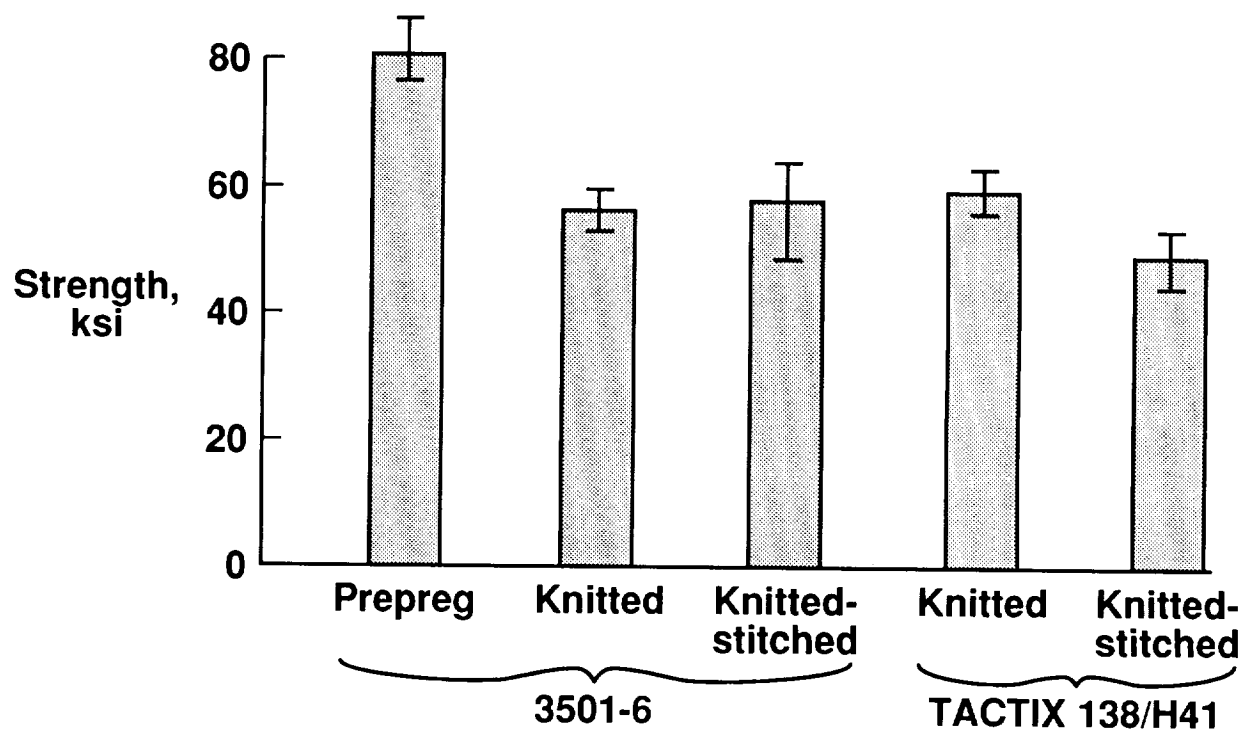
Figure 18

Average compression strengths for the Hexcel Hi-Tech knitted and knitted-stitched fabrics are shown in figure 18. The average strength of the knitted and knitted-stitched fabrics is approximately 32 percent lower than the strength of the prepreg tape laminates. The failure mode for the tape and knitted laminates consisted of extensive ply delaminations, whereas the failure mode of the knitted-stitched laminates was primarily a transverse shear mode. Although the failure mode was significantly different between the knitted and knitted-stitched laminates, the stitching did not improve the strength. In fact, the strength of the knitted-stitched laminates with Tactix 138/H41 resin was lower than the strength of the knitted laminates. Since the modulus of the Tactix 138/H41 resin is lower than the modulus of the 3501-6 resin, it is expected that the compression strength of the laminates with Tactix 138/H41 resin would be lower.

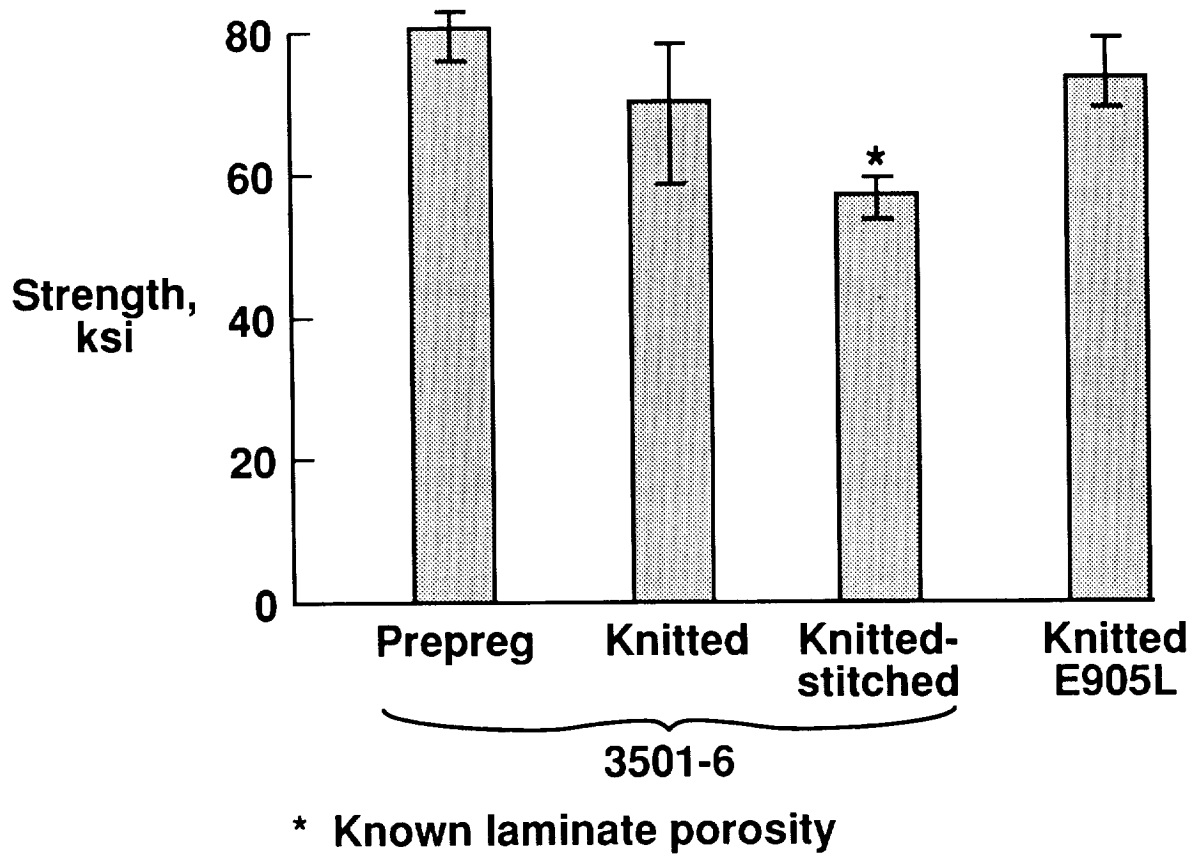
Figure 19

Average compression strengths for the Milliken knitted and knitted-stitched fabrics are shown in figure 19. The knitted fabrics with 3501-6 and E905L resins had compression strengths that were only about 10 percent lower than the strength of the prepreg tape laminates. There was only one Kevlar 29 stitched laminate available for testing; due to processing problems, this laminate had considerable porosity and its compression strength was lower than it should have been. Additional Milliken laminates will be fabricated and tested to assess the performance of Kevlar 29 stitching and E905L resin. The Milliken knitted fabric had better compression strength than the Hexcel Hi-Tech knitted fabric.
